GROUNDWATER SURVEY  
HD. WILLUNGA, SEC. 772

GROUNDWATER SURVEY

Hundred Willunga, Section 772

Rept.Bk.No. 73/27  
G.S. No. 5033  
Hyd. No. 2478  
D.M. No. 107/73

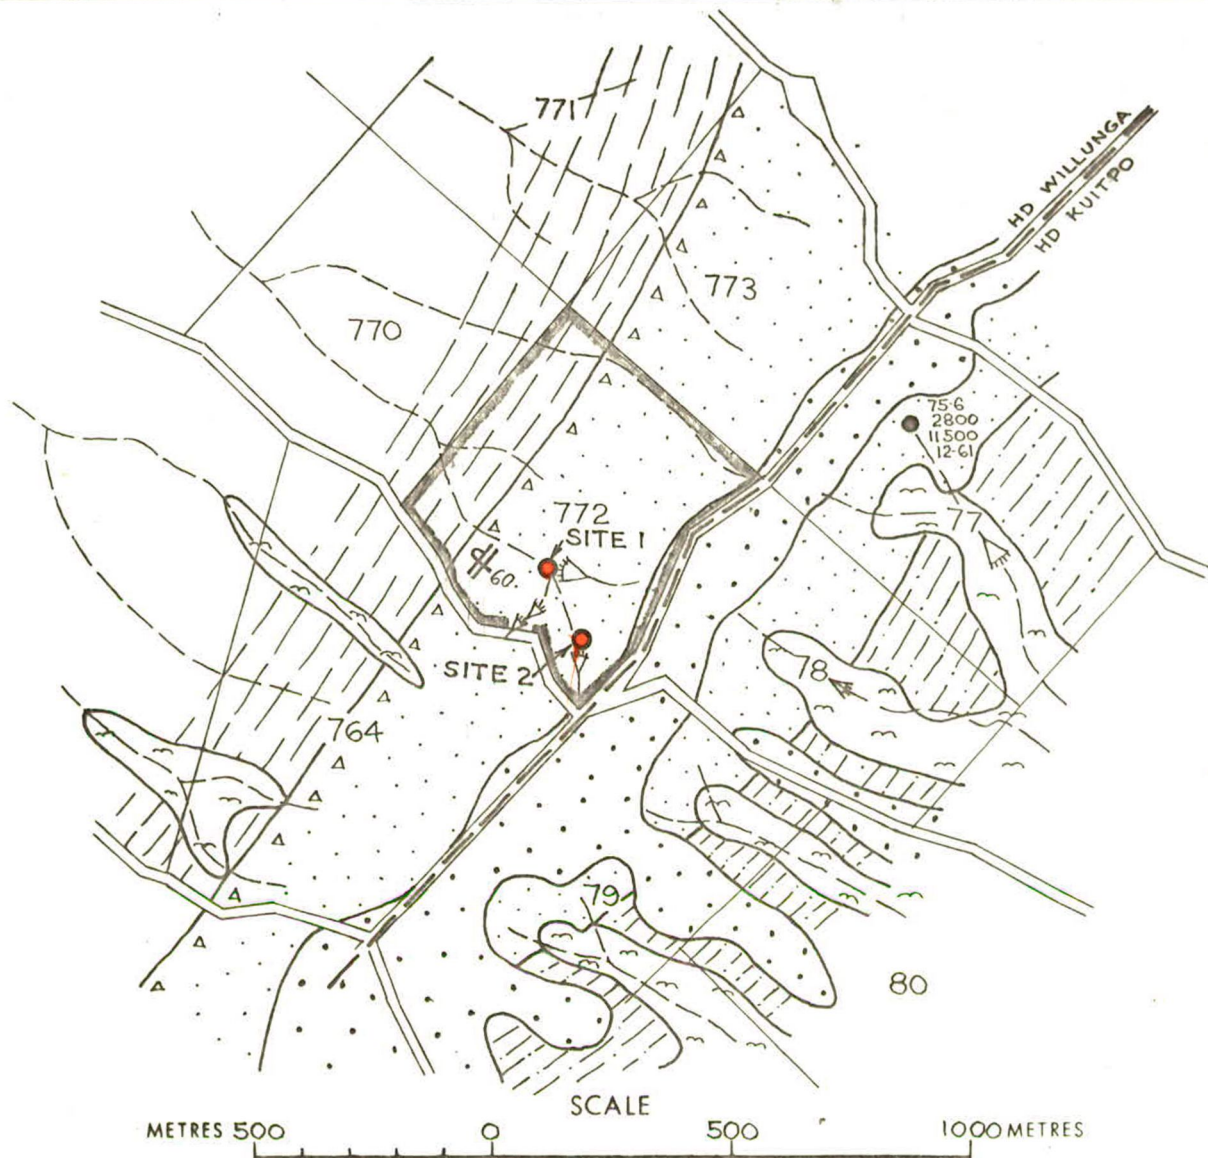
Extent: The aquifer (the quartzite bed) underlies the property in several areas. Two prominent quartzites strike across the property (running northeast-southwest) and it is considered that irrigation supplies should be found in these beds.

Reason for location: High rainfall (and thence good potential recharge) and the fractured and porous nature of the aquifer imply good chances of obtaining reasonable supplies of irrigation water. Site 1 should obtain larger supplies than site 2 but would require extra pumping as the difference in head could be as much as 30 m.
