GROUNDWATER SURVEY

Hd. Noarlunga Pt. Sec. 425

Hundred: Noarlunga Pt. Sec. 425

Rept.Bk.No. 74/22 G.S. No. 5338 Hyd. No. 2617 D.M. No. 1189/73

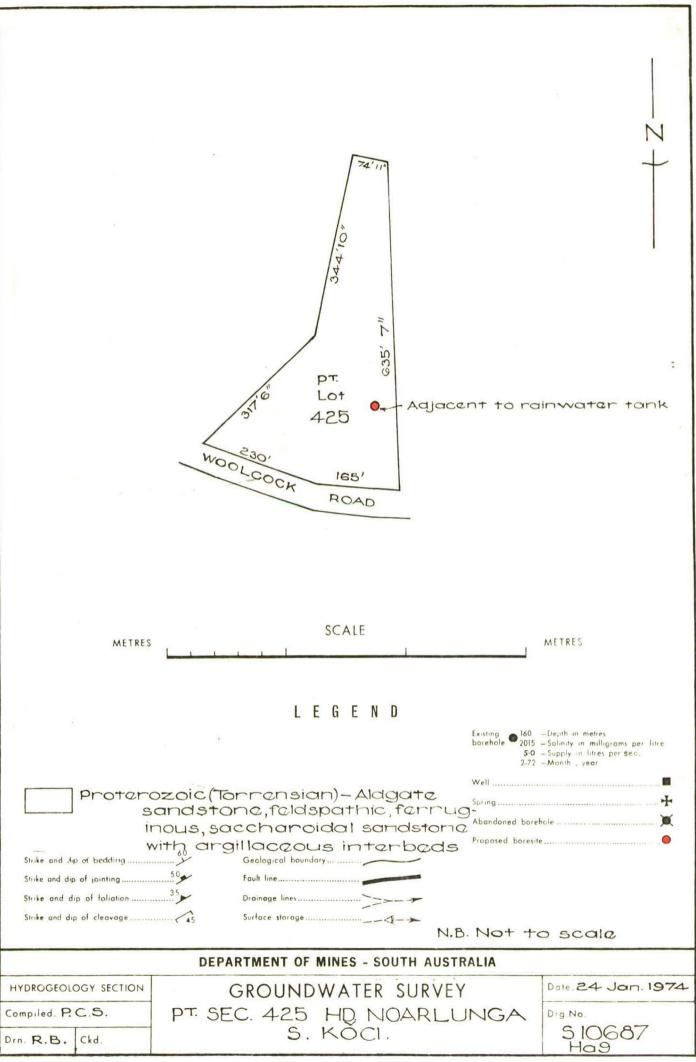
General: A site adjacent to the tank base on the eastern side of the house is recommended to be drilled. Its position is plotted on the accompanying plan.
