# WHITE DAM GOLD MINE

# Quarterly Compliance Report

1<sup>st</sup> January 2014 to 30<sup>th</sup> June 2014 (combining 1<sup>st</sup> and 2<sup>nd</sup> quarters)

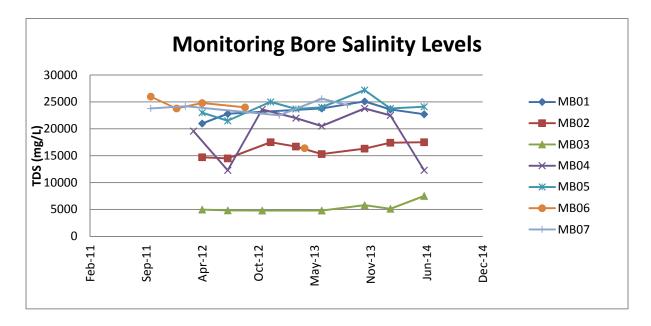
**Figure 4: Monitoring Bore Salinity Levels**

Figure 4 below shows the changes in salinity levels at monitoring bores over time. Bores are sampled quarterly (when accessible). This shows minimal change to salinity levels and within expected natural fluctuations.

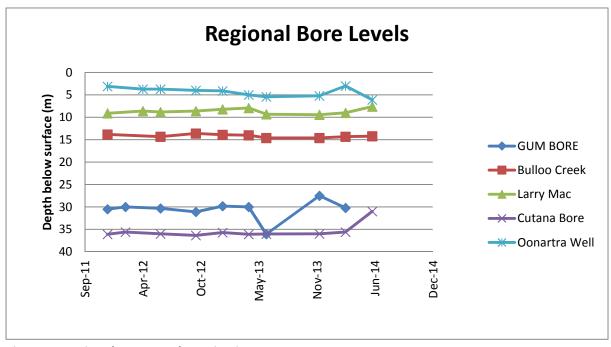
**Figure 5: Regional Bore Level Monitoring**

Figure 5 below indicates that there has been minimal change to bore water levels throughout most regional bores during this and previous reporting periods. As was the case with the previous compliance report, Gum Bore could not be sampled due to its active use at the time of visiting however discussions with the landholder have indicated that bore water quality and level remains unchanged in terms of quality for stock usage.

found that the bores which show drawdown of
	>7m are within the 2km measurement zone so
	drawdown at 2km and beyond is considered
	likely to be within this compliance level (no
	effect has been observed at regional bores(see
	above regarding Gum Bore). MB06 has a
	significant cone of depression however water
	levels are expected to indicate recharge in the
	future due to cessation of mining and
	associated extraction. It has been continually
	demonstrated during the course of the mining
	and groundwater extraction operations that
	drawdown effects have been localised in scale.
The pastoralist has agreed that if the salinity of	Last reporting period indicated that salinity
the water in Gum Bore reaches 3000 TDS, his	levels in Gum Bore remain stable, and well
use of the water will be adversely affected.	under the compliance level of 3000mg/L TDS
Thus the trigger point (criterion) for remedial	(note that Gum Bore could not be sampled

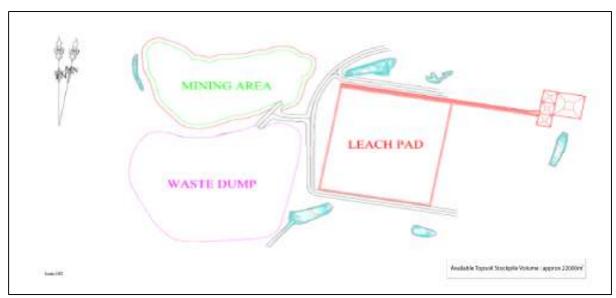
Figure 6: Topsoil stockpile inventory within the White Dam project site<sup>11</sup>

Topsoil stockpiles during mining operations were surveyed once a month, used and residual volumes recorded both diagrammatically (Figure 6) and values recorded. Based on surveys to date, there is sufficient topsoil stockpiled to enable completion of the site rehabilitation program. To date, most topsoil has been used in the rehabilitation of the Hannaford and Vertigo WRDs. Additional topsoil is available from stripping undertaken prior to the development of the two pits. A check undertaken in late 2012 of these stockpiles confirmed remaining volumes as given in Table 10. An estimated 17,623m<sup>3</sup> of topsoil is required to cover the leach pad to a depth of 100mm with additional lesser volumes for other rehabilitation uses such as roads and infrastructure areas. The remaining volumes are sufficient for these requirements. There has been no topsoil recovery and usage during the reporting period.

Table 20. Gallinia, G. Topour Colaines (iii )				
Topsoil Stockpile	Original Volume	Cumulative	Remaining	
Name		Usage		
TSP1	7261	7261	depleted	
TSP2	2005	2005	depleted	
TSP3	2749	inaccessible	inaccessible	
TSP4	19518	19518	depleted	
TSP5	9034	nil	9034	
TSP6	1145	nil	1145	
TSP7	6984	nil	6984	
TSP8	2994	nil	2994	
TSP9	9836	8336	1500	
TSP10	779	779	depleted	
TSP11	2000	2000	depleted	
TSP12	2248	2248	depleted	
Total	66553	42147	21657
